Minerals Inspection Report

Report Date: 04/08/2015

Mine Name: County Canyon Shale		Permit Number:	M/023/0024	4 Mine Status:	Active
Operator Name: Ash Grove Cement Company		Inspection Date:	04/07/2015	Permit Fees:	Paid
Inspe	ctor(s): Wayne Western	Inspection Time:	9:50 - 10:00 a	am Bond Amount:	\$166,000
Attendee(s): Josh Nelson Weath				Bond Escalation:	07/19/2017
Inspection Purpose: Routine inspection				Prior Inspection:	03/11/2014
Conclusions and Recommendations The pit was idle in 2013 and 2014. The Operator did haul material off site during those years. The Operator plans on resuming operations in 2015.					
Elements of Inspection				Evaluated & Commented	Enforcement

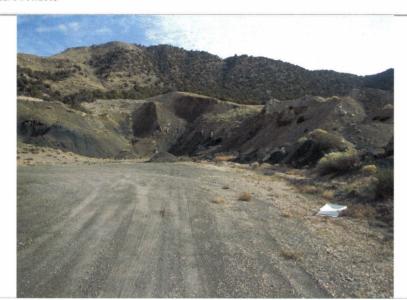
1.	Permits, Revisions, Transfer, Bonds			\boxtimes	
	The fees and bond are current				
2.	Public Safety (shafts, adits, trash, signs, highwalls)				
	There were several tire tracks in the area indicating that the public will access the site. Last Sunday was Easter. During Easter weekend the Little Sahara Sand Dunes receives 20,000 to 30,000 visitors. Many of the visitors look for places to camp in the area. There are no underground openings or other significant hazards at the site.

Pit looking east. Tire tracks indicate the public accesses the site.

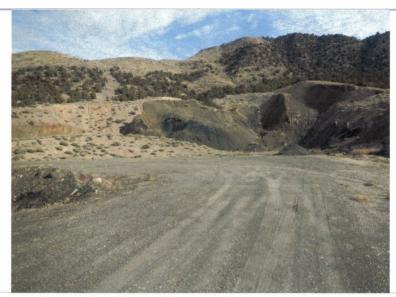
Pit looking north west. Pit walls are stable- no erorsion.

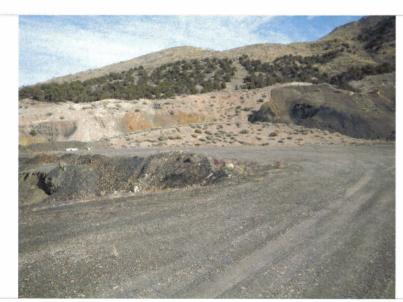
Bottom pit looking northwest

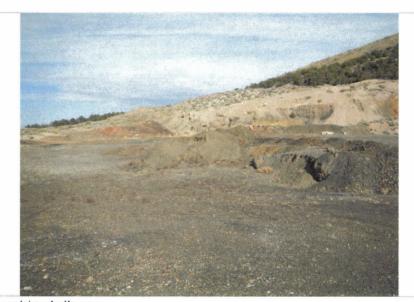
Bottom pit/stockpile area.
